# Energy Savings through Pump Refurbishment and Coatings

Karen Verosky, Henkel Corporation (Loctite®) and Paul Maier, Randy White, Steve Connell, Kurt Knoll, Chris King, George Hanley and Richard Metzger, Monroe County Water Authority

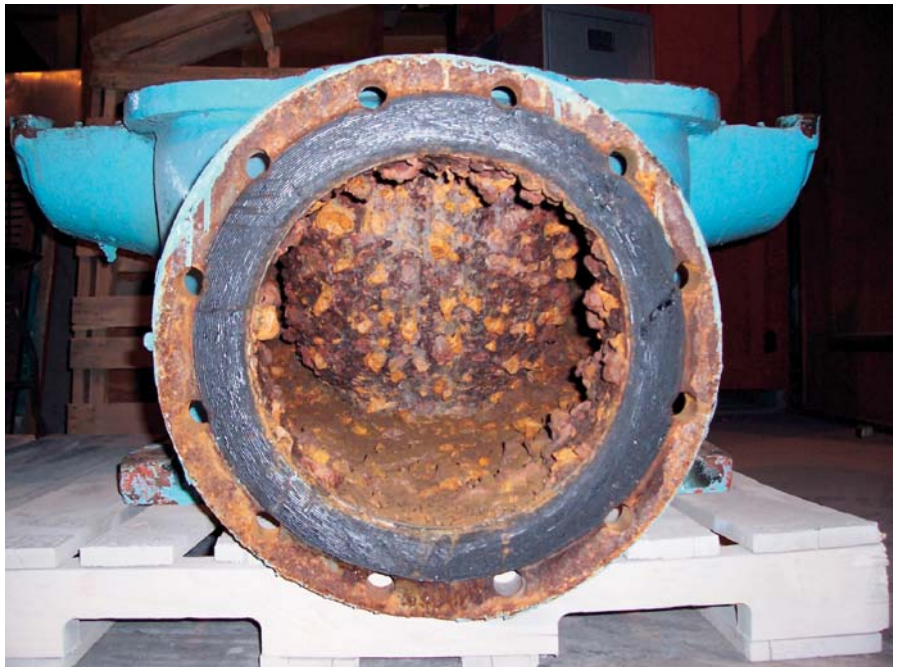
Figure 1. Pump interior with severe tuberculation

During the teardown for mechanical repair, MCWA noticed extensive tuberculation buildup on the interior casings of all pumps. Tuberculation, the knob-like mound byproducts of corrosion that build up on the interior walls of pumps and unlined piping systems, has long challenged engineers and maintenance professionals in the water industry. For more than 50 years, the industry standard for pipeline manufacturers has been to apply a cement lining to the inside of cast and ductile iron pipe used in municipal water distribution systems to prevent corrosion and tuberculation buildup.

The MCWA team began a pilot study to refurbish several interior casings of the mechanically rebuilt pumps to see if reducing interior pump roughness would have any positive impact on pump performance and efficiency. Since only sandblasting the interior pump casings would allow corrosion and tuberculation to return quickly, the team began looking for acceptable coatings that could be applied after sandblasting to protect the interior surface from future corrosion and perhaps even enhance the reduction of head loss/hydraulic drag through the pump.

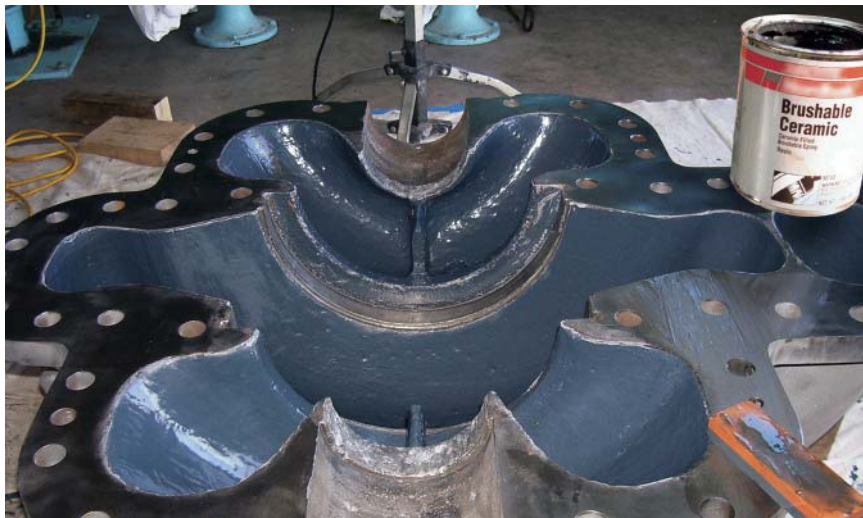
**Figure 2. Pump interior after coating with brushable ceramic epoxy**

The MCWA team started by filling in any deep pitted areas or gouges with a metal-filled epoxy and allowed that to cure before applying two 15-mil thick coats of brushable ceramic. Although inexperienced with these epoxy products, the team found them generally easy to apply, although it was initially difficult to be neat on the larger pumps. In addition to using short nap brushes and rollers designed for epoxy application, they also found inexpensive items such as household

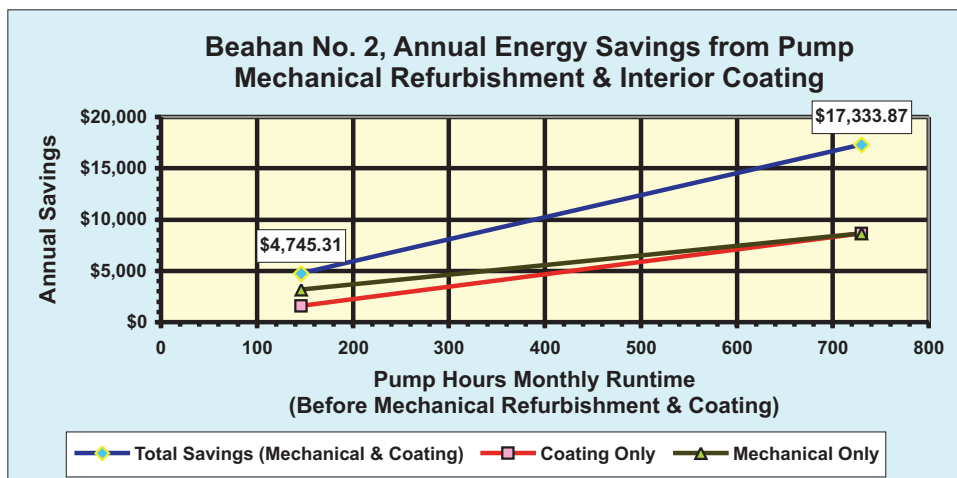
Figure 3

Energy analyses also revealed that mechanical refurbishment alone could only achieve about half of the total potential energy savings of a pump compared to what could be achieved if the pump was sandblasted and coated in addition to being mechanically refurbished. This is illustrated by the results for MCWA's Beahan No. 2 unit (see Figure 3).

Beahan No. 2 pump is a 300-hp pump located at a key pump station in the MCWA's distribution system. Installed in 2000, this pump had a manufacturer's stated efficiency of 88 percent at the pump's best efficiency point (BEP), pumping 6,000-gpm at 150-ft of head. By 2006, pump efficiency at the BEP had dropped to 77.8 percent. The pump was first sandblasted and coated, which increased pump efficiency at the BEP to 85.2 percent (an increase of 9.5 percent). Mechanical refurbishment increased efficiency at the BEP an additional 3.3 percent, which brought the pump back to original manufacturer's specifications.

As shown in Figure 3, it was also calculated that half (\$8,500) of the savings could be attributed specifically to sandblasting and coating—savings that would not have been achieved if the pump had only received the traditional mechanical refurbishment. The MCWA team estimates that if all of its 100+ pumps were mechanically refurbished, sandblasted and coated, the MCWA could realize energy cost savings in excess of several hundred thousand dollars from its \$4 million annual energy budget.
