Paper Mill Seals Leaky Gear Box With Loctite® 587™ Blue High Performance Oil-Resistant Silicone *Eliminates Oil Loss and Associated Labor Costs*

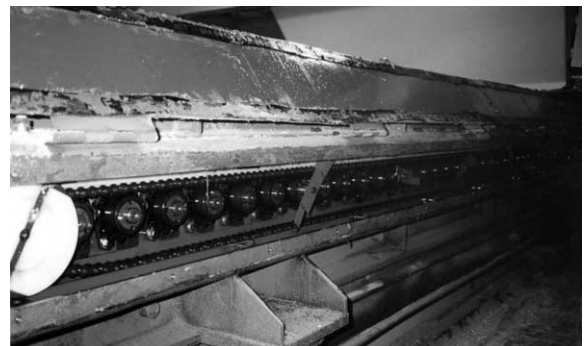
For years a pulp and paper mill in British Columbia, Canada endured oil seeping from the gear box of the Diamond Roll machine. Maintenance personnel repeatedly replaced the seals on the gear box cover, but puddles still formed on the top of the equipment. After many hours of labor and gear oil loss, they knew there had to be a better solution.

Loctite® 587™ Blue High Performance Silicone was able to seal the cover of the gear box on this Diamond Roll, eliminating oil leakage and associated labor costs.

During a regularly scheduled shutdown, maintenance personnel applied the one-component, ready-to-use Loctite 587 Blue in a continuous bead around the gear box mating surface. The cover was then replaced and the machine was ready for use after a one-hour cure.

Loctite 587 Blue High Performance Silicone formed a reliable gasket that lasted until the next required maintenance. The mill has reduced oil consumption and kept their equipment cleaner. In addition, needless labor costs have also been eliminated.
