APPLICATION CASE HISTORY

No. 254

Loctite® Fixmaster® Deep Pour Grout Repairs Concrete Floor Base in Hot Roll Steel Mill

Repair ensures long application life under tough conditions

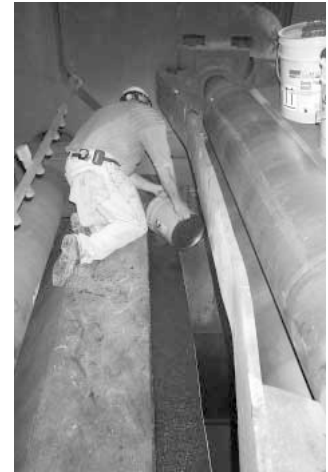
A worldwide leader in rolled steel technology was having problems with the concrete floor wearing and crumbling along the edge of the de-scale pit under the hot rolled steel production line. The problem was due to dime-sized de-scale particles coming off, under pressure from the hot rolled process steel, and hitting with direct force against the edge of the de-scale pit. Maintenance personnel had tried unsuccessfully to repair the 75-square foot area by applying concrete patch compound with binder additives. The repair of the floor was critical because the wearing area was less than 18" away from the foundation on which the rolling steel production equipment was set. If allowed to continue, the wearing could cause a weakening of the stable equipment base. This, in turn, could adversely affect the finished product quality, and ultimately cause a production shutdown to replace the entire foundation, costing hundreds of thousands of dollars in downtime.

The entire front edge of the de-scale pit area was chiseled down approximately 6" to properly prepare the application surface. A piece of one-eighth inch thick steel plate was tack welded along the edge of the pit to act as a retaining crib to contain the self-leveling Fixmaster Deep Pour Grout and serve as a front edge support buffer.

The inside seams of the plate along the edge of the pit were sealed with Loctite® Superflex® Non-Corrosive RTV Silicone Clear compound to contain the poured material while in liquid form prior to cure. The Fixmaster Deep Pour Grout was then mixed and applied by pouring directly into the cribbed/support area. The pour was made to a depth of 5", purposely leaving a 1" gap at the top. After a 24-hour cure time, the remaining 1" to the top of the floor edge and steel crib plate was completed by mixing and troweling a layer of Nordbak® Wearing Compound. Nordbak Wearing Compound is a high-performance epoxy system containing large ceramic beads and fine silicon carbide particles, which protect against sliding abrasion to 250°F. This was to form an additional buffer or shield to protect the underlying material.

Normally, the Fixmaster product and the Nordbak product each require a 24-hour cure time. But as the hot roll steel production equipment was still quite warm, it produced an oven-curing effect at approximately 110°F in the area of the application, thus, decreasing the epoxy cure time. This allowed the repair to be made during the short window of scheduled production equipment downtime. In addition, the repair was deemed successful when the floor failed to crumble once the equipment was up and running again and, after many months of production time, was still holding strong.
