APPLICATION CASE HISTORY NO. 269

Loctite® Nordbak® Brushable Ceramic Repairs Pump Casing In Just Five Hours

Plant Saves Over \$10,000 & Five Weeks Downtime

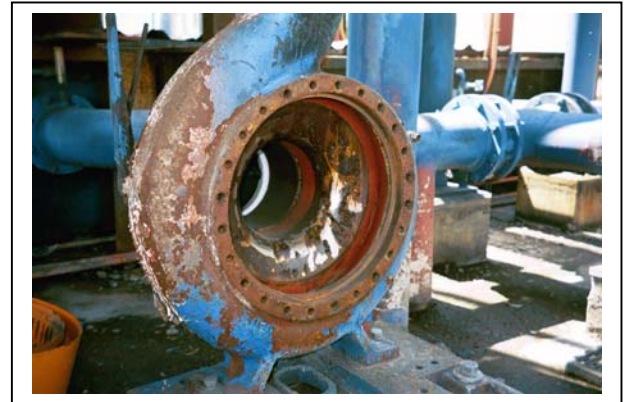
One of the world's premier producers of custom steel line pipe to the energy industry, as well as pipe for structural applications, oil country casing, and water conveyance, recently saved over \$10,000 using Loctite® products. This plant, which sits on 20 acres of property, is cooled with two separate cooling towers. During a scheduled pump teardown and inspection, maintenance personnel noticed severe wear to the casing of one of the pumps. The voids worn in the casing averaged in size from 1/8" pits to 1/2" x 3" gouges.

The casing of the pump (top) is severely pitted and gouged from wear and friction. After blasting the interior to a Near White Metal Finish, Loctite® Fixmaster® Superior Metal is used to fill the voids (bottom).

To prepare the damaged interior surface of the casing, fine grade black blasting media and an inexpensive hopper-style sand blasting rig was used to achieve a Near White Metal Finish. All remaining blasting media was removed using compressed air. Loctite® ODC-Free Cleaner & Degreaser was then liberally sprayed as a final cleaning step.

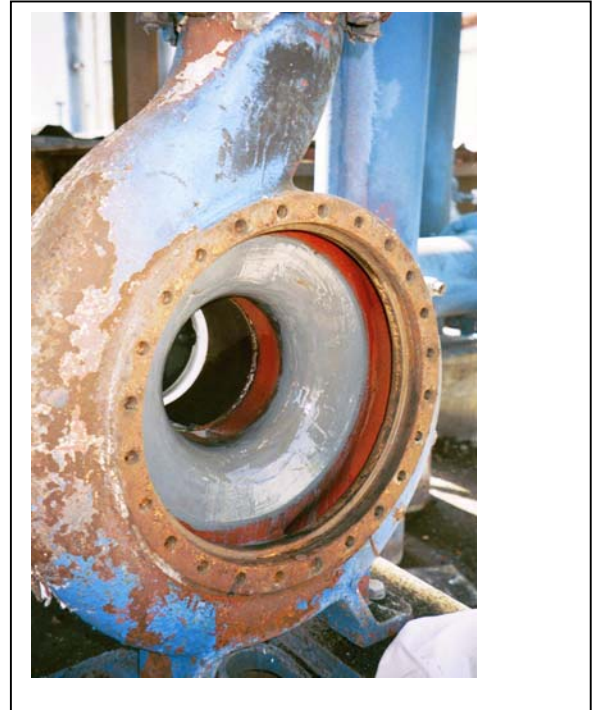
After troweling and smoothing the Loctite® Fixmaster® Superior Metal evenly to the inside casing (top), Loctite® Nordbak® Brushable Ceramic is applied to create a smooth, low-friction coating (bottom).

Next, Loctite® Fixmaster® Superior Metal was used to fill all the casing pock marks and then evenly troweled over the damaged inside casing. Loctite® Fixmaster® Superior Metal is formulated with high compressive strength and chemical resistance. It has a fast curing time of 20 minutes and is non-rusting. Once this was done, isopropyl alcohol was misted onto the surface to provide lubricity, and trowel marks left in the Loctite® Fixmaster® Superior Metal were smoothed with a nitrile-gloved hand.
