LOCTITE*Adhesives for more
reliable assemblies***APPLICATION CASE HISTORY****No. 215**

GASKET ELIMINATOR® PREVENTS PACKING SLEEVES FROM SEIZING

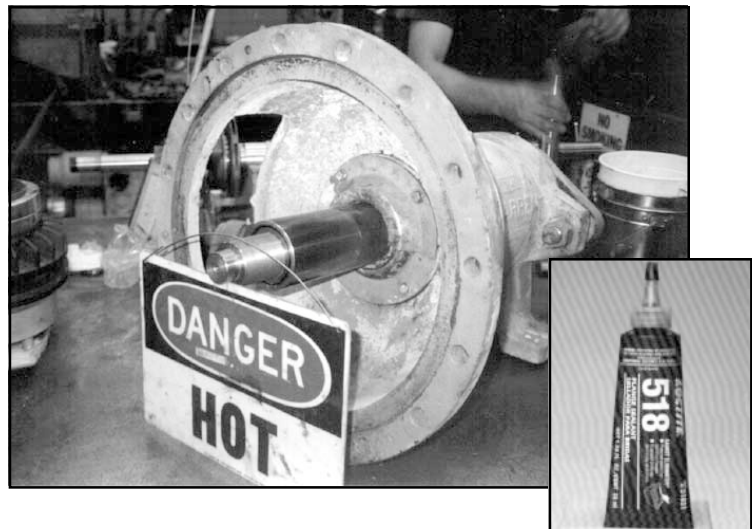
The problem was discussed during a session of the Loctite Manufacturing Reliability Training Process being conducted at the paper mill. The Loctite Adhesives & Sealants Specialist suggested using Loctite® Gasket Eliminator® 518 as a light retaining compound and sealant. By applying Gasket Eliminator 518 to both ends of the sleeve, the fluid flow was stopped, thus eliminating corrosion and corresponding seizure. The sleeves were also prevented from rotating and fretting on the shaft.

Several pumps have been put into service using this method without any corrosion or seizure problems. Removal of the sleeves and cleanup of the shaft has been simplified; parts assembled with Gasket Eliminator 518 are easily disassembled by applying localized heat to the bond area. This pump rebuilding process has eliminated the need to cut the sleeve with torches, thereby avoiding bearing frame damage.
