Loctite® 5920™ Copper High Temperature Silicone Seals Fiberglass Gasket In Place With No Leaks

Thermal Generating Station Scheduled Shutdown Maintenance Log

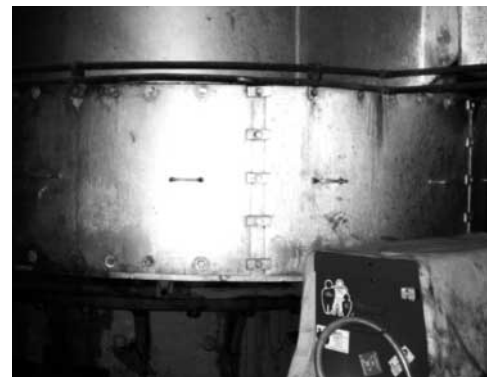
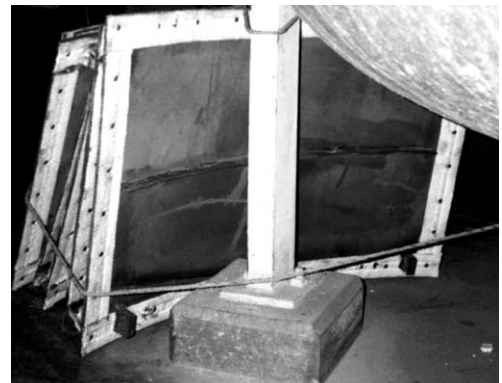
Loctite® 5920™ Copper securely seals pulverizer doors to prevent potential coal dust leaks, yet doors remain easily removable for service or inspection.

Maintenance Engineers applied Loctite 5920 Copper by manually dispensing beads of the sealant to the fiberglass gaskets of the windbox panel doors. Loctite 5920 Copper seals any potential coal dust leaks, especially where the ladder tape stretches around the rivets that hold it in place. The ladder tape, dressed with Loctite 5920 Copper, is easy to remove and when the covers need to be removed for service work or inspection, Loctite 5920 Copper peels off to allow for reapplication.
